P.R.O.S. - Property Reports On Sight

Exterior of Property

Interior of Property:

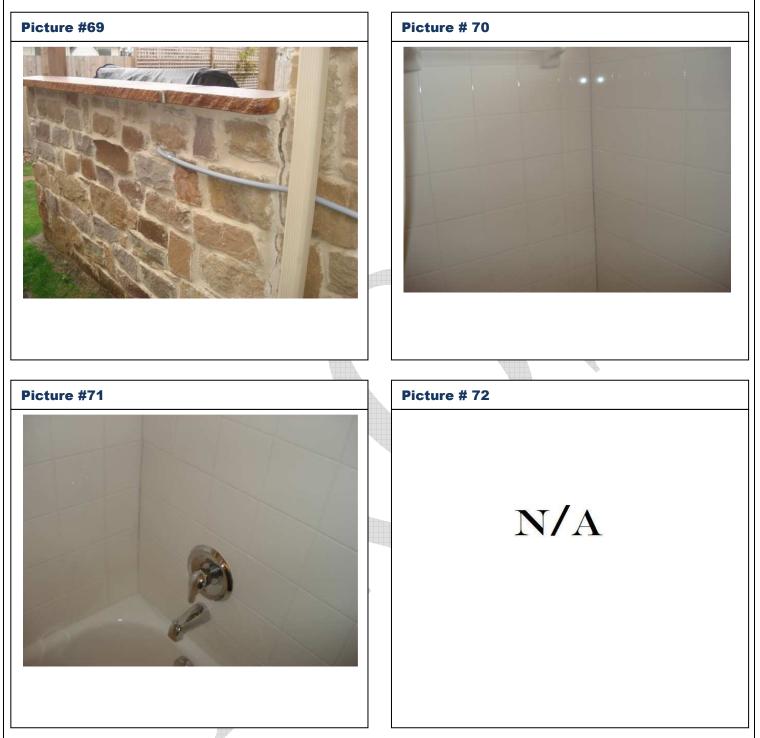
Comments: #69Separation in grout of rear left wall partition brickwork of Rear Patio framing, vertical gutter system adjacent.#71-72Separation in caulking along vertical edges of tile work to 2nd Bathroom shower/tub unit framing.
