P.R.O.S. - Property Reports On Sight

Exterior of Property

Interior of Property:

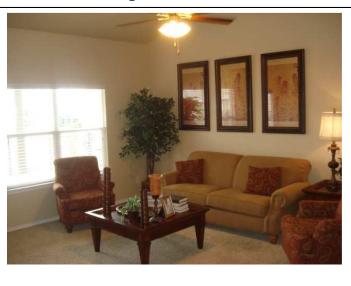
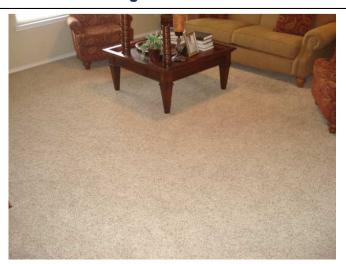
Picture #11 Porch/Steps Picture #12 Entry/Foyer D-R-HOHETON -W If no safety issues or deficiencies observed NO COMMENTS will be Made. Living Room/Great Room Observed Unobserved See Additional Pictures/Needs Further Evaluation 9. Flooring \times 10. Walls/Paint $\overline{\times}$ 11. Light Fixture 12. Blinds/Drapes 13. Windows 14. Ceiling Fan X \boxtimes 15. Outlet/Switch Covers 16. Other **Picture #13 Living Room Picture #14 Living Room Floor**

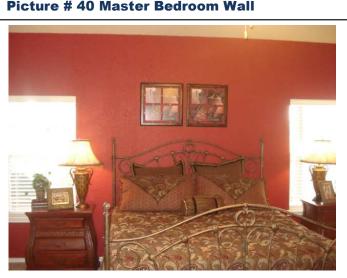
If no safety issues or deficiencies observed NO COMMENTS will be Made. Master Bedroom Observed Unobserved See Additional Pictures/Needs Further Evaluation 33. Flooring \boxtimes 34. Walls/Paint \times 35. Light Fixture \langle 36. Blinds/Drapes 37. Windows 38. Ceiling Fan 39. Outlet/Switch Covers 40. Other Picture # 38 Ceiling (Fan/Smoke Detector?) **Picture #37 Master Bedroom Picture #39 Master Bedroom Floor** Picture # 40 Master Bedroom Wall
